Lemanaghan Wind Farm

Stage 1 Road Safety Audit

Alan Lipsombe Traffic & Transport Consultants Ltd

March 2026

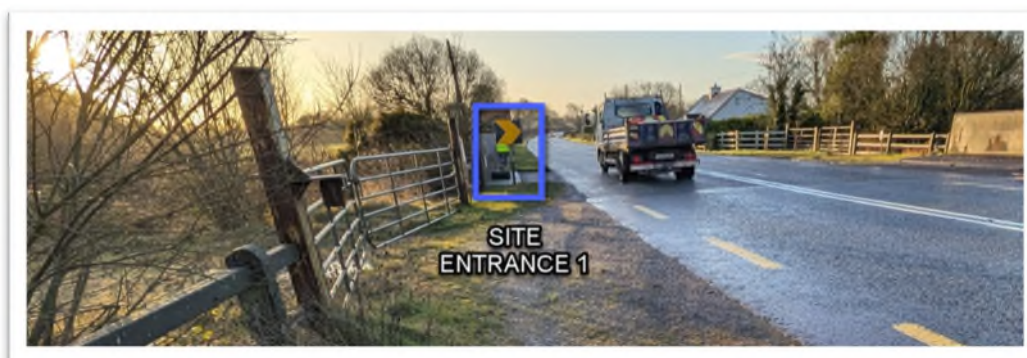
Figure 2.1 – The Existing Chevron Board Will Partially Obscure the Access Sight Lines

2.1 Problem: Road Sign Partially Obscuring Visibility

Location: Site Entrance 1 | Existing Chevron Board to South of Site Entrance 1

The line of sight looking to the left for drivers attempting to exit the access appeared to be partially obscured by an existing chevron board. This could increase the risk of side impact type collisions at the access.

Recommendation

The chevron board should be relocated to a suitable position which does not obscure visibility.

2.1	Yes	Yes	The relocation of the chevron board will be agreed with TII and Offaly County Council prior to finalising the detailed design of the proposed junction.	Comment noted

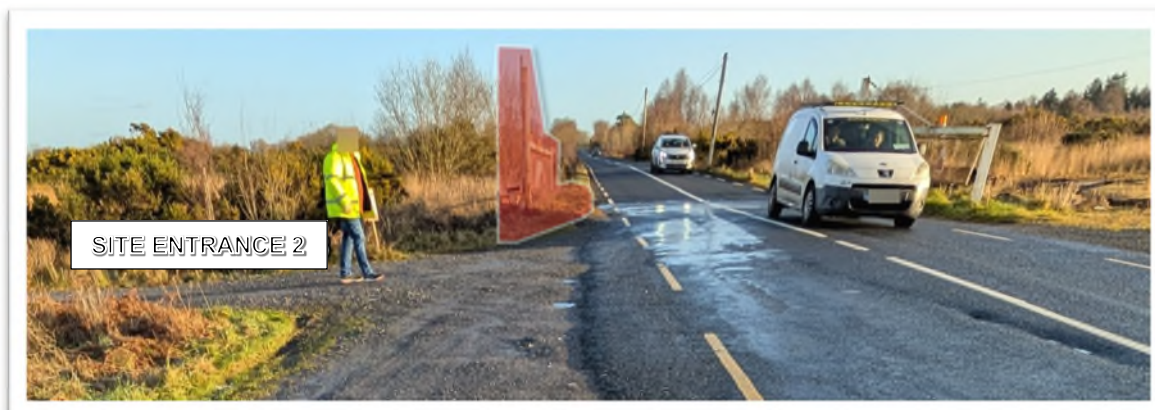
Figure 2.2 – Drivers Exiting from Access – View to Left Obscured by Level Crossing Gate

2.2 Problem: Visibility Splays Obscured Looking to Left

Location: Site Entrance 2 | Redundant Level Crossing Gate

The line of sight looking to the left for drivers attempting to exit the access appeared to be partially obscured by a redundant level crossing gate. This could increase the risk of side impact type collisions at the access.

Recommendation

The level crossing gate should be removed so that it does not obscure visibility.

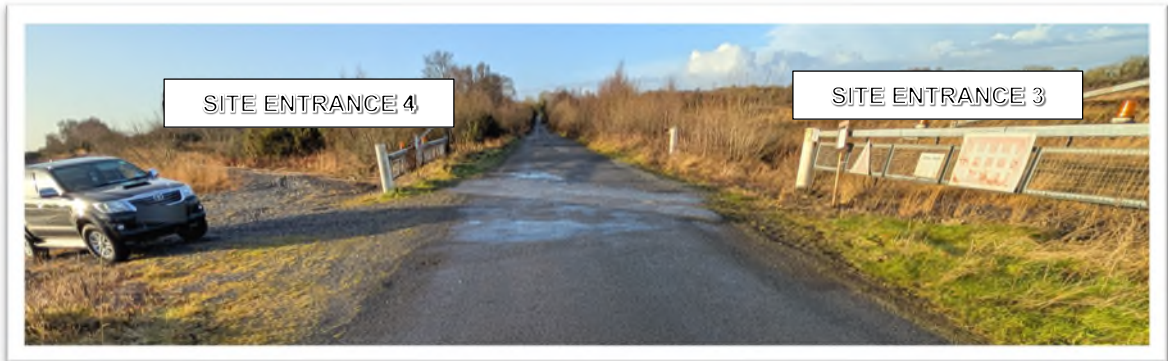
Figure 2.3 – Image of Site Entrance 3 & Site Entrance 4 – Record Purposes Only

2.3 Problem: No Road Safety Issues Identified

Location: Site Entrances 3 & 4 | Existing Opposing Accesses on L7002

No road safety issues were identified for these site access points.

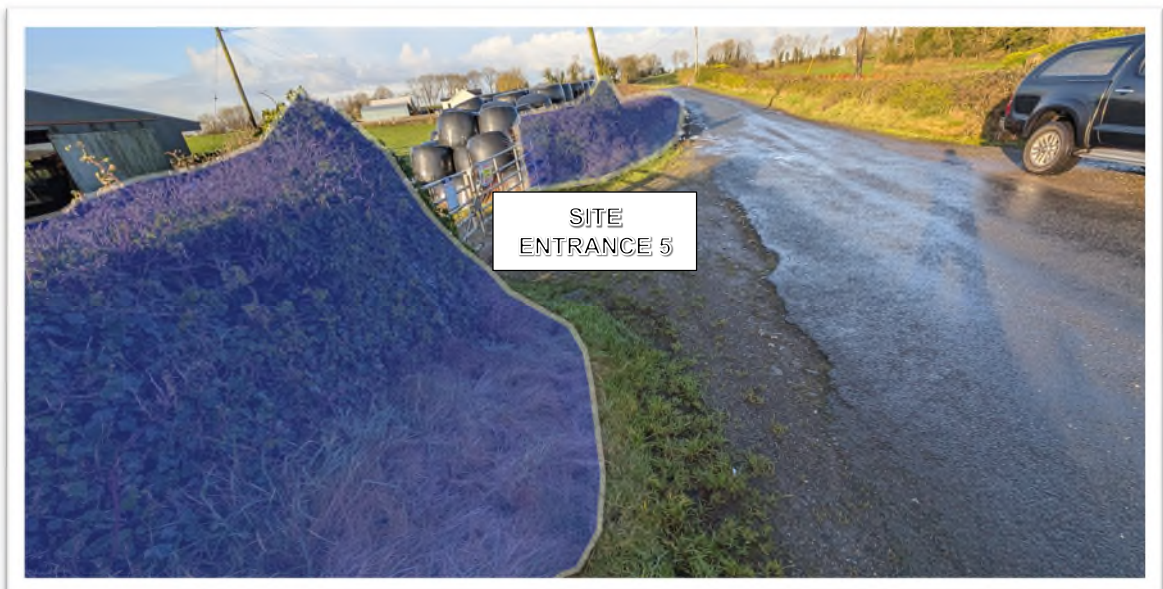
Figure 2.4 – Visibility Splays Partially Obscured in Both Directions at Site Entrance 5

2.4 Problem: Visibility Splays Obscured in Both Directions

Location: Site Entrance 5 | Existing Boundary Treatments Either Side of Access

Drivers attempting to leave the access will have their view blocked in both directions by the existing field boundary. This limited visibility could increase the risk of side-impact collisions at the access.

Recommendation

The field boundary should be modified to ensure that an appropriate level of visibility can be provided for drivers exiting the access.
