**GEOTECHNICAL & PEAT  
STABILITY RISK  
ASSESSMENT REPORT**

# LEMANAGHAN WIND FARM, CO. OFFALY

## Geotechnical & Peat Stability Risk Assessment Report

# Geotechnical & Peat Stability Assessment Report Lemanaghan Wind Farm

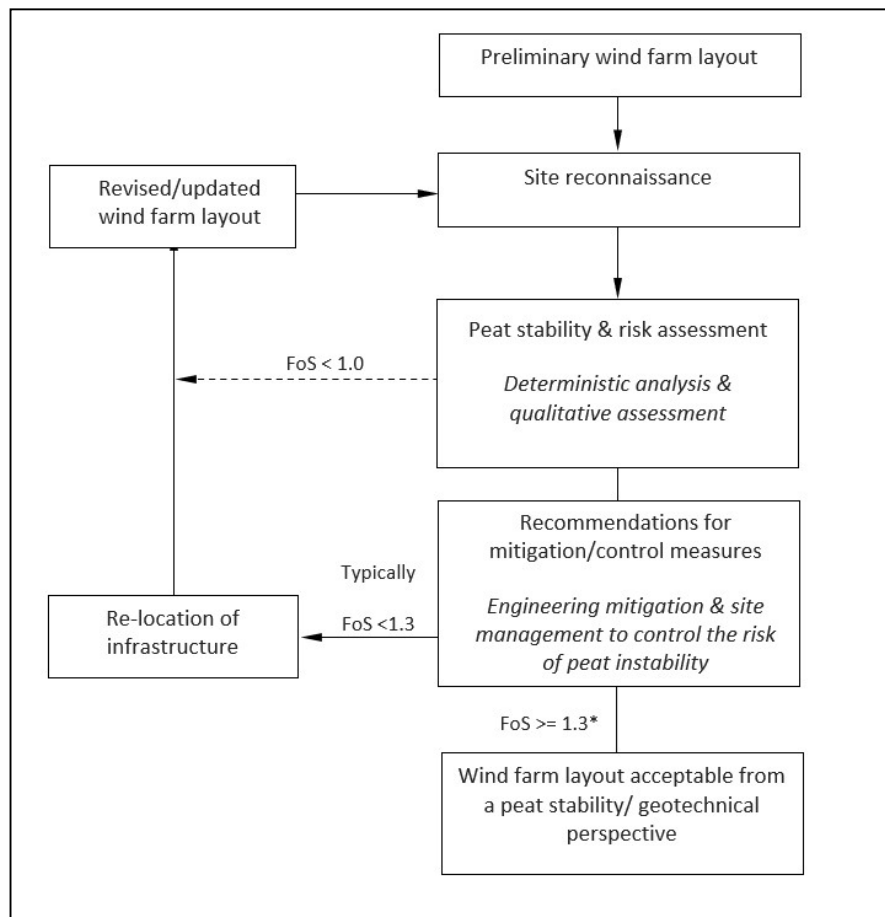
A flow diagram showing the general methodology for the peat stability assessment is shown in Figure 2-1. The methodology illustrates the optimisation of the wind farm layout based on the findings from the site reconnaissance and stability analysis and subsequent feedback.

\*An FoS of between 1.0 and 1.3 does not mean that a failure will occur, but that the area requires attention. Mitigation measures can be provided for areas with an FoS of between 1.0 and 1.3 to reduce the risk of failure.

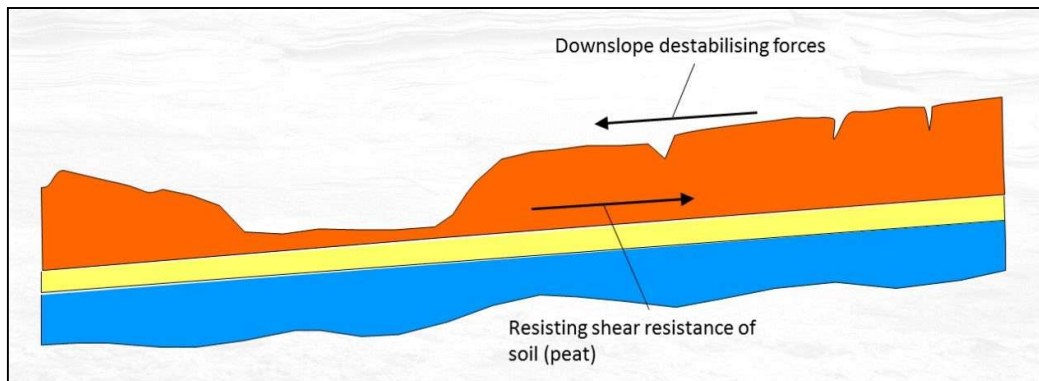
Figure 2-2: Peat Slope Showing Balance of Forces to Maintain Stability

The FoS is a measure of the stability of a particular slope. For any slope, the degree of stability depends on the balance of forces between the weight of the soil/peat working downslope (destabilising force) and the inherent strength of the peat/soil (shear resistance) to resist the downslope weight, see Figure 2-2.

The FoS provides a direct measure of the degree of stability of a slope and is the ratio of the shear resistance over the downslope destabilising force. Provided the available shear resistance is greater than the downslope destabilising force then the FoS will be greater than 1.0 and the slope will remain stable. If the FoS is less than 1.0 the slope is unstable and liable to fail. The acceptable factor of safety for assessment purposes is 1.3 (BS6031, 1981).

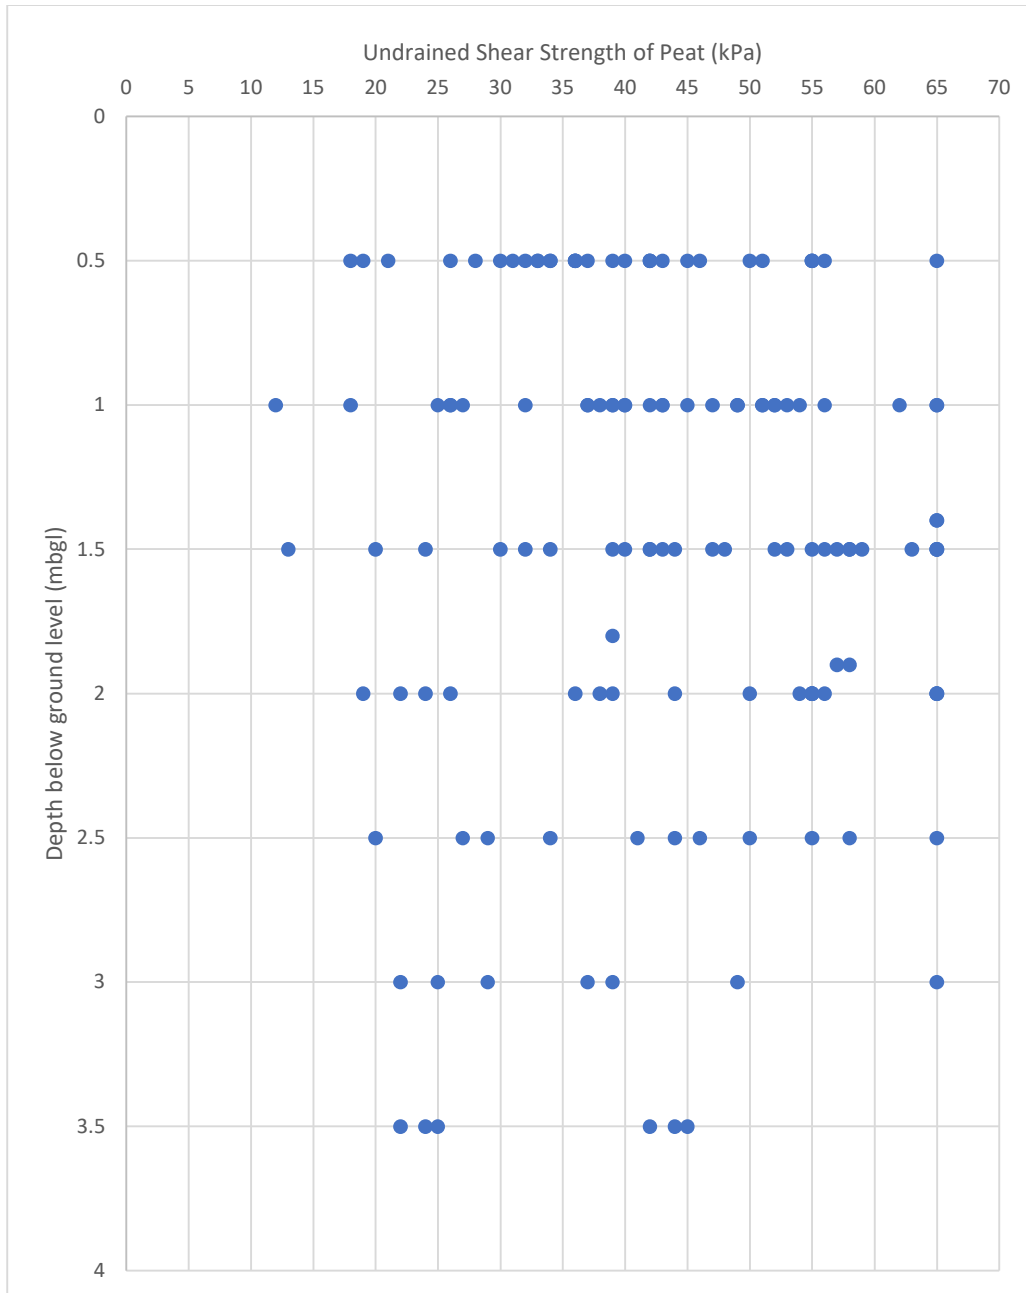
Figure 6-1: Undrained Shear Strength (cu) Profile for Peat with Depth

Peat strength at sites of known peat failures (assuming undrained loading failure) are generally very low, for example the undrained shear strength at the Derrybrien failure (AGEC, 2004) as derived from back-analysis, was estimated at 2.5kPa. The recorded undrained strength at the Proposed Project site is significantly greater than the lower bound values for Derrybrien indicating that there is no close correlation to the peat conditions at the Derrybrien site and that there is significantly less likelihood of failure on the Proposed Project site.

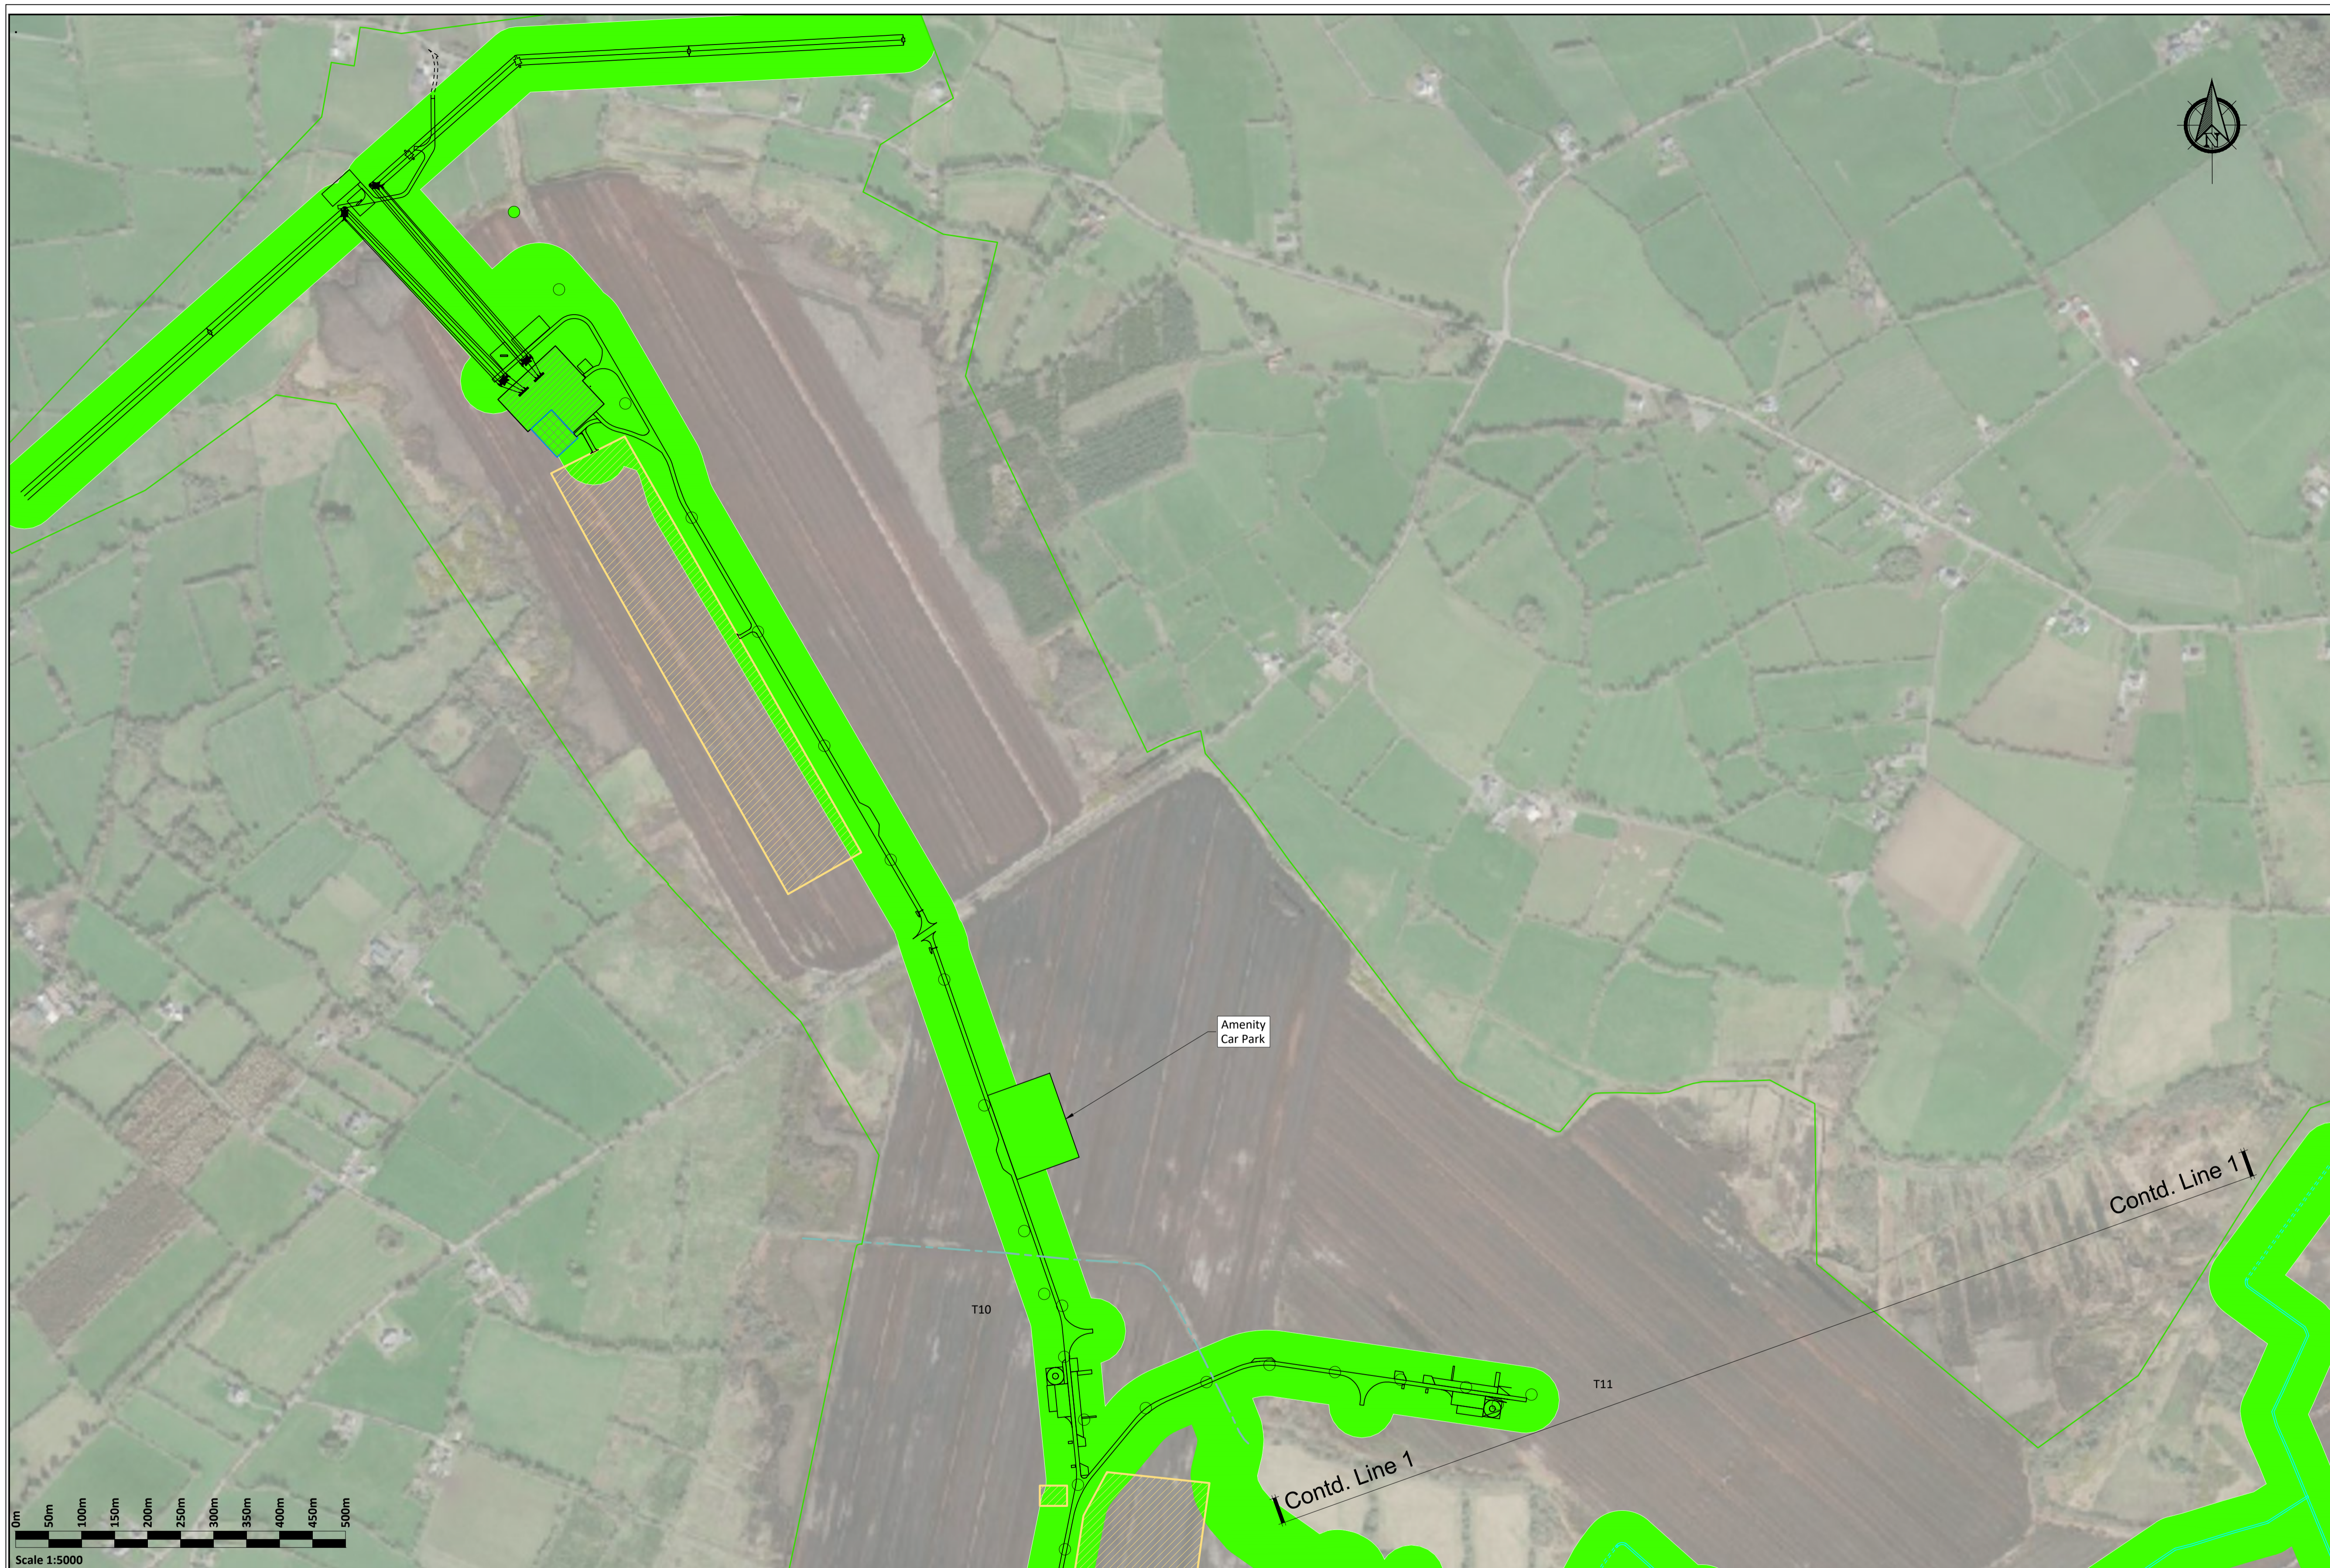
- Factor of Safety Legend:**
- 0 < 1.0 ■
  - ≥ 1.0 < 1.3 ■
  - ≥ 1.3 ■
- Increasing Stability ↓
- No Peat Recorded At This Location ●

5. Factor of safety plan – compiled for the short-term critical condition (undrained) for 281 no. FoS points analysed along the proposed infrastructure envelope on site.

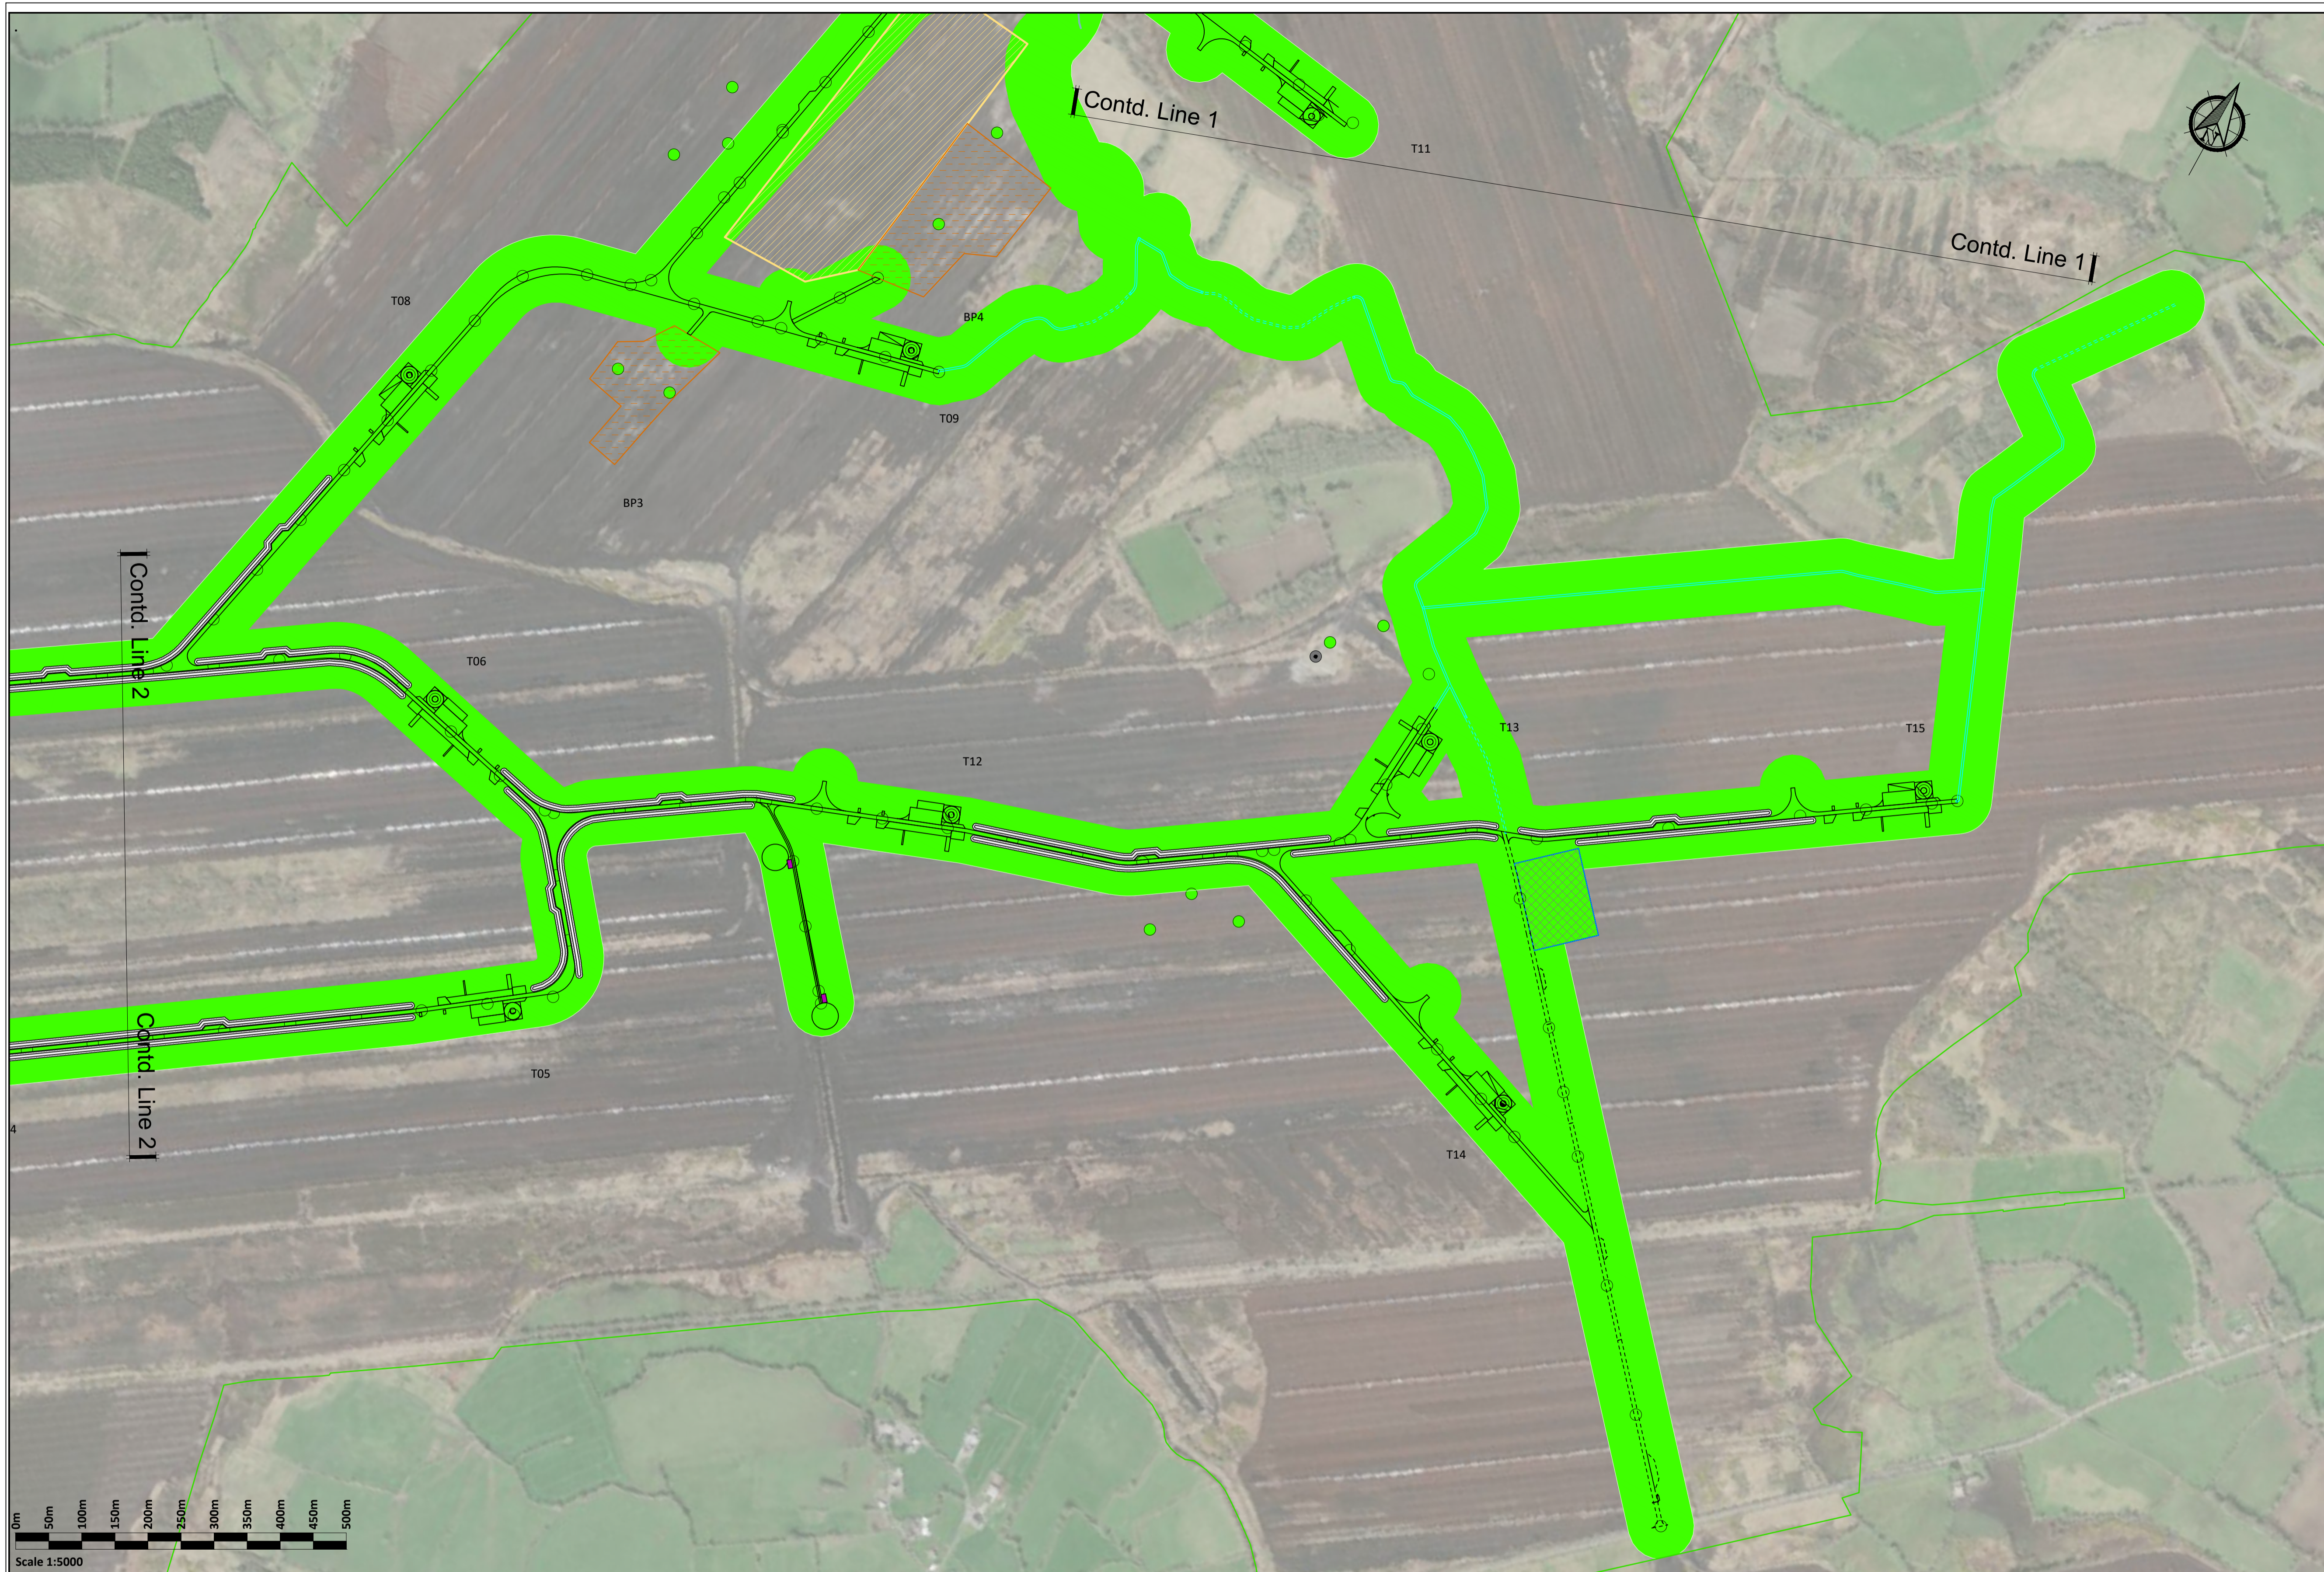
- Factor of Safety Legend:**
- 0 < 1.0
  - ≥ 1.0 < 1.3
  - ≥ 1.3
  - No Peat Recorded At This Location
- Increasing Stability ↓

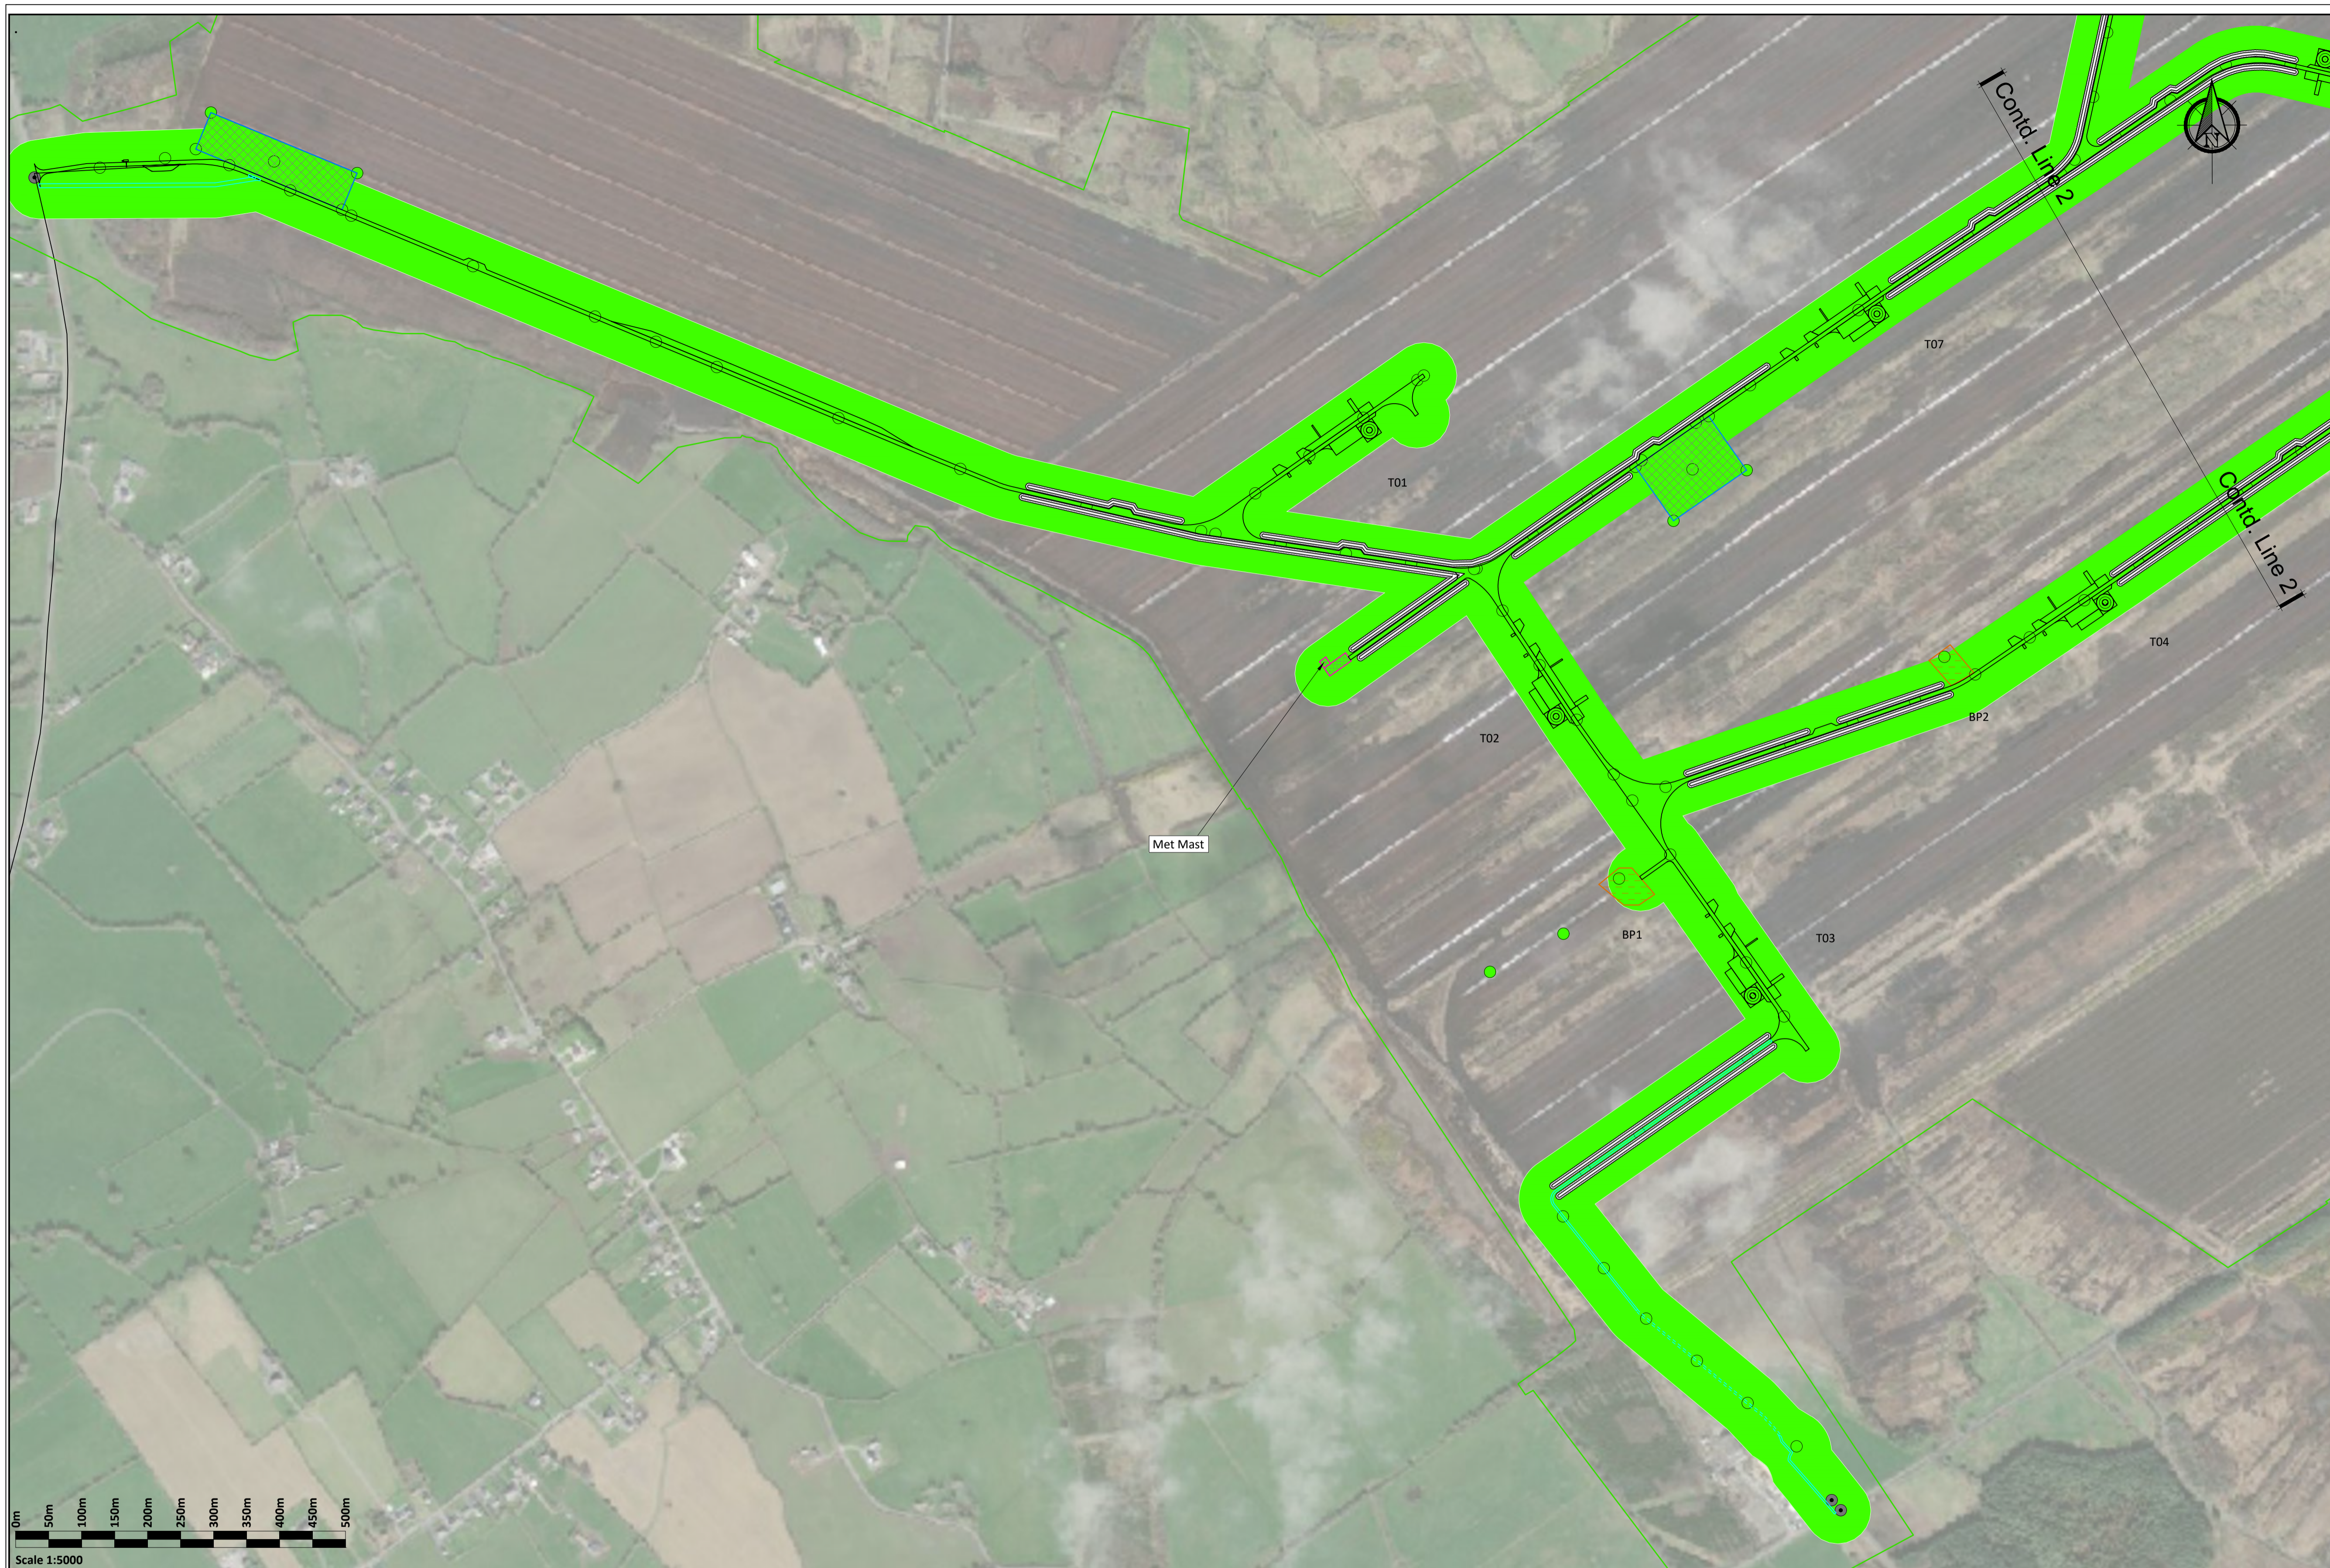
- Factor of Safety Legend:**
- 0 < 1.0
  - ≥ 1.0 < 1.3
  - ≥ 1.3
  - No Peat Recorded At This Location
- Increasing Stability ↓

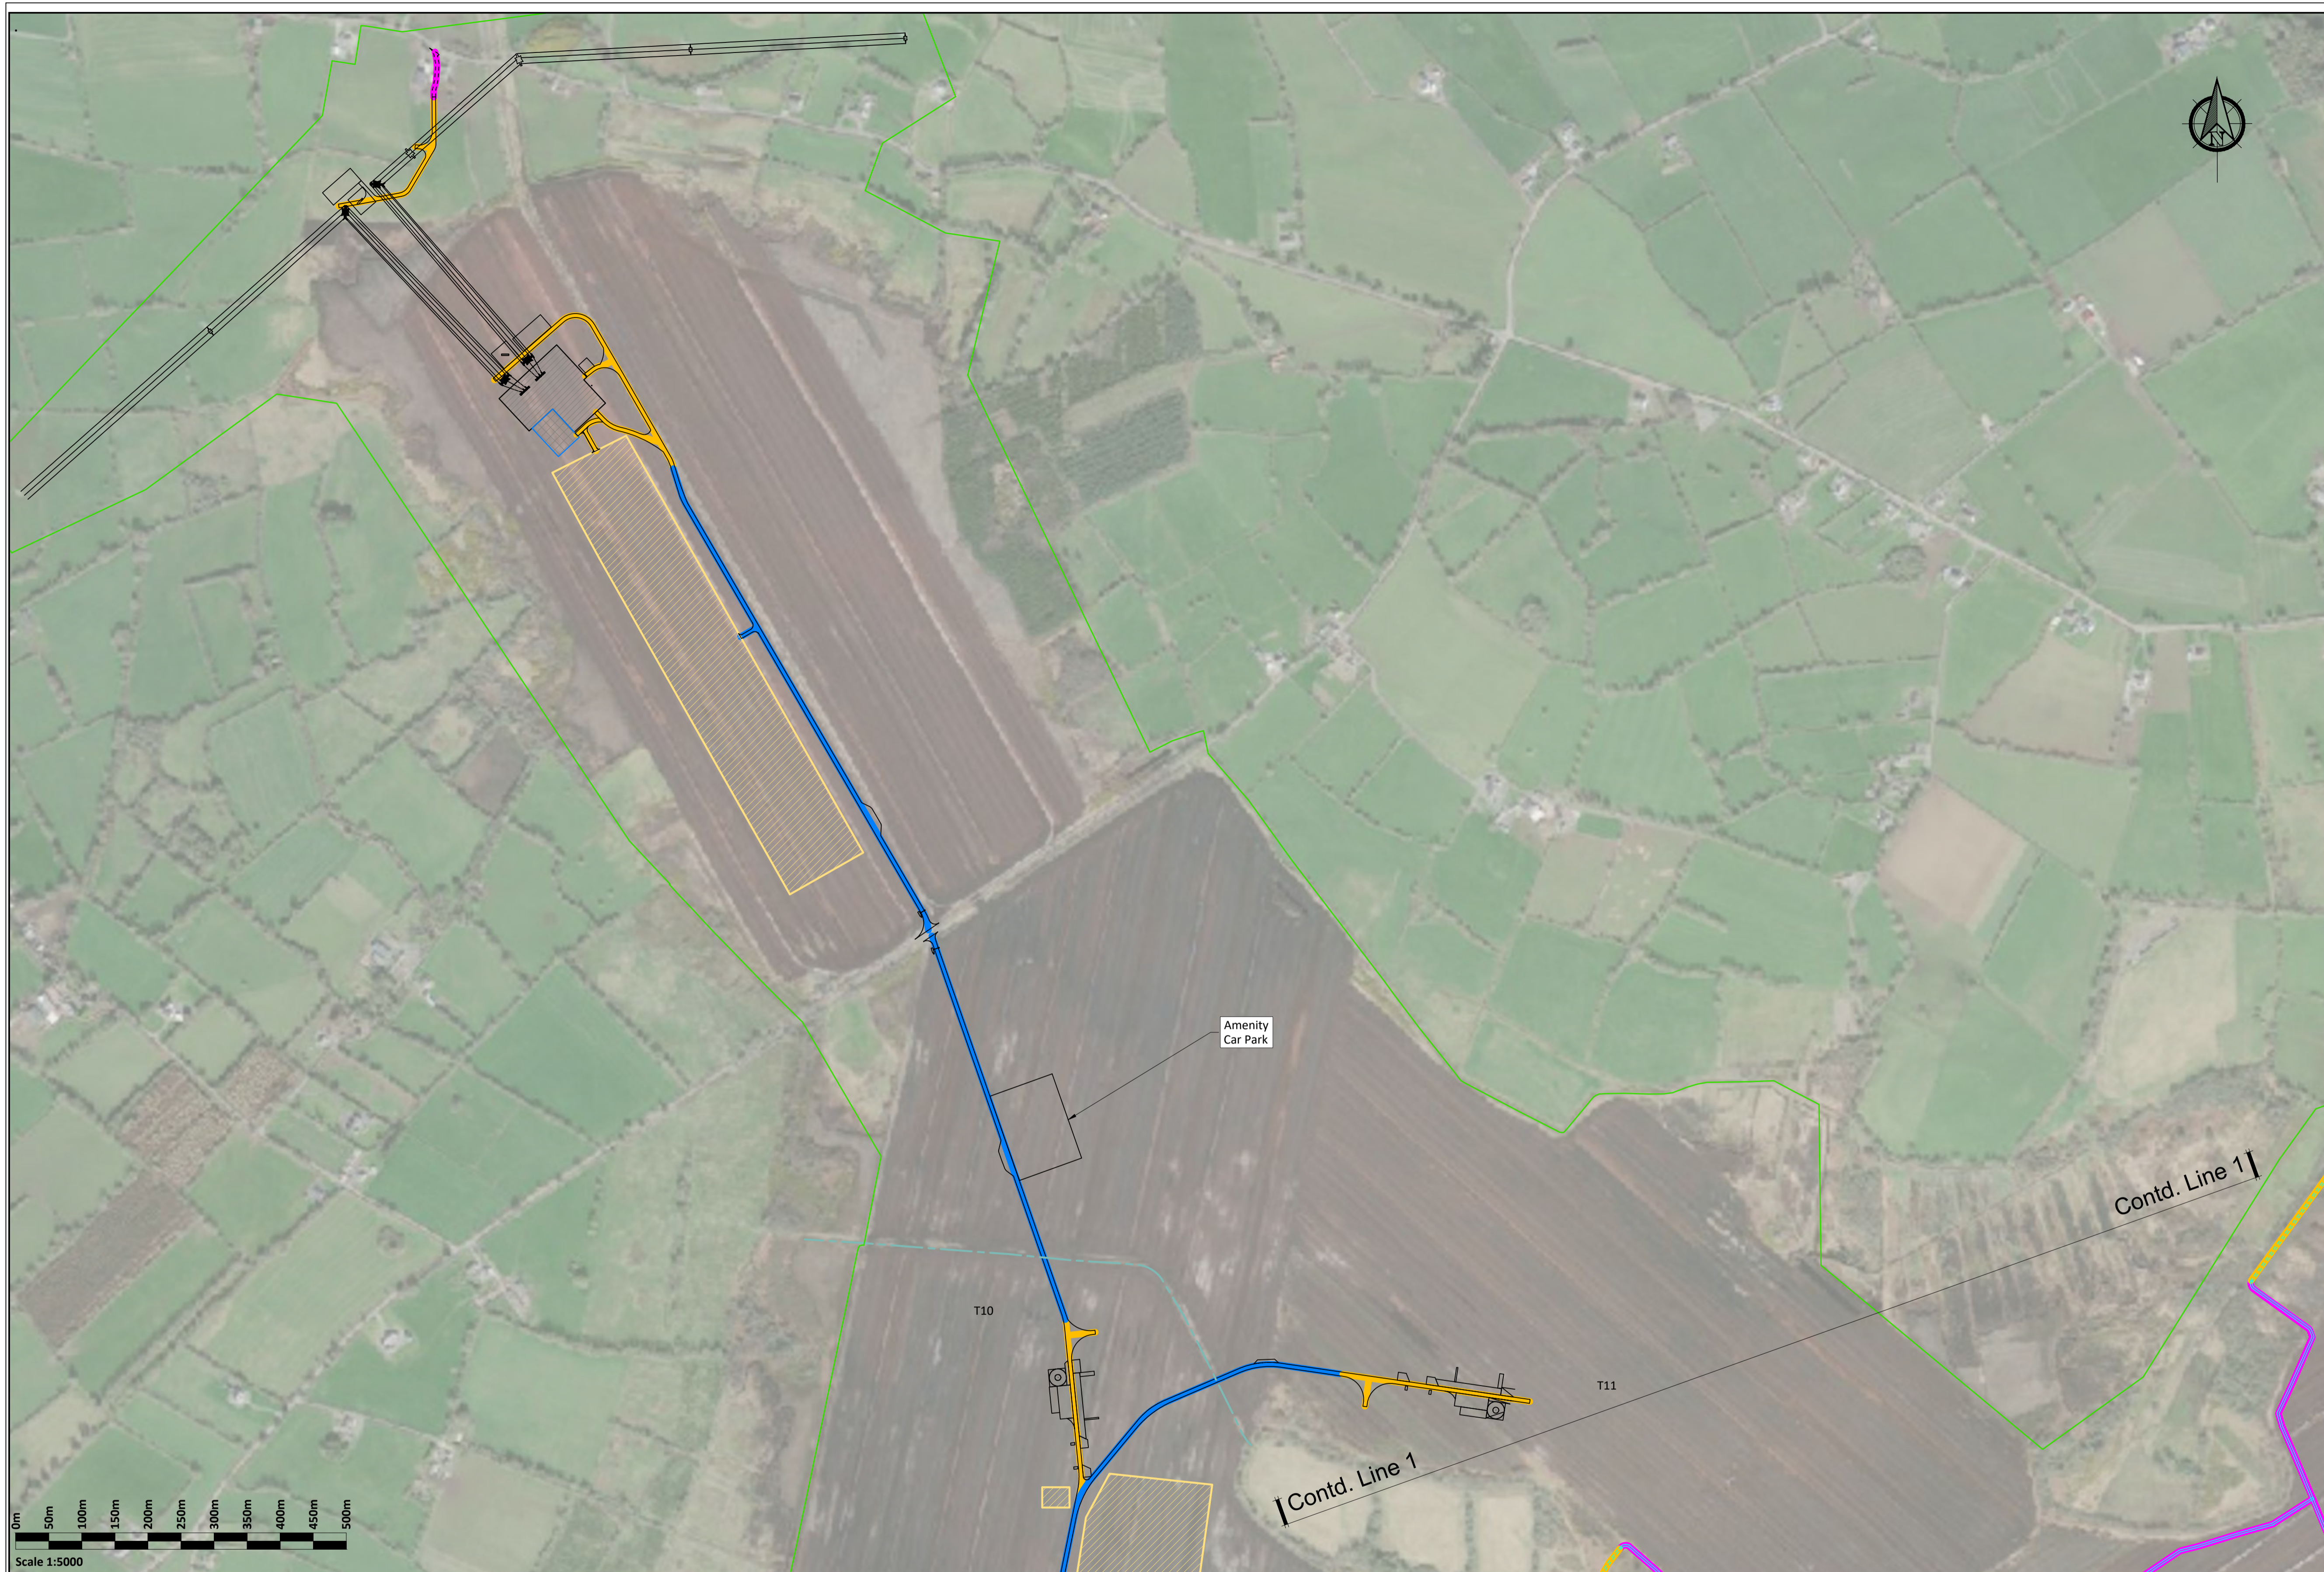
- Road Type Legend:**
- Type A - New Excavate & Replace Internal Track
  - Type B - New Floated Internal Track
  - Type C - Upgrade of Existing Excavated Internal Track

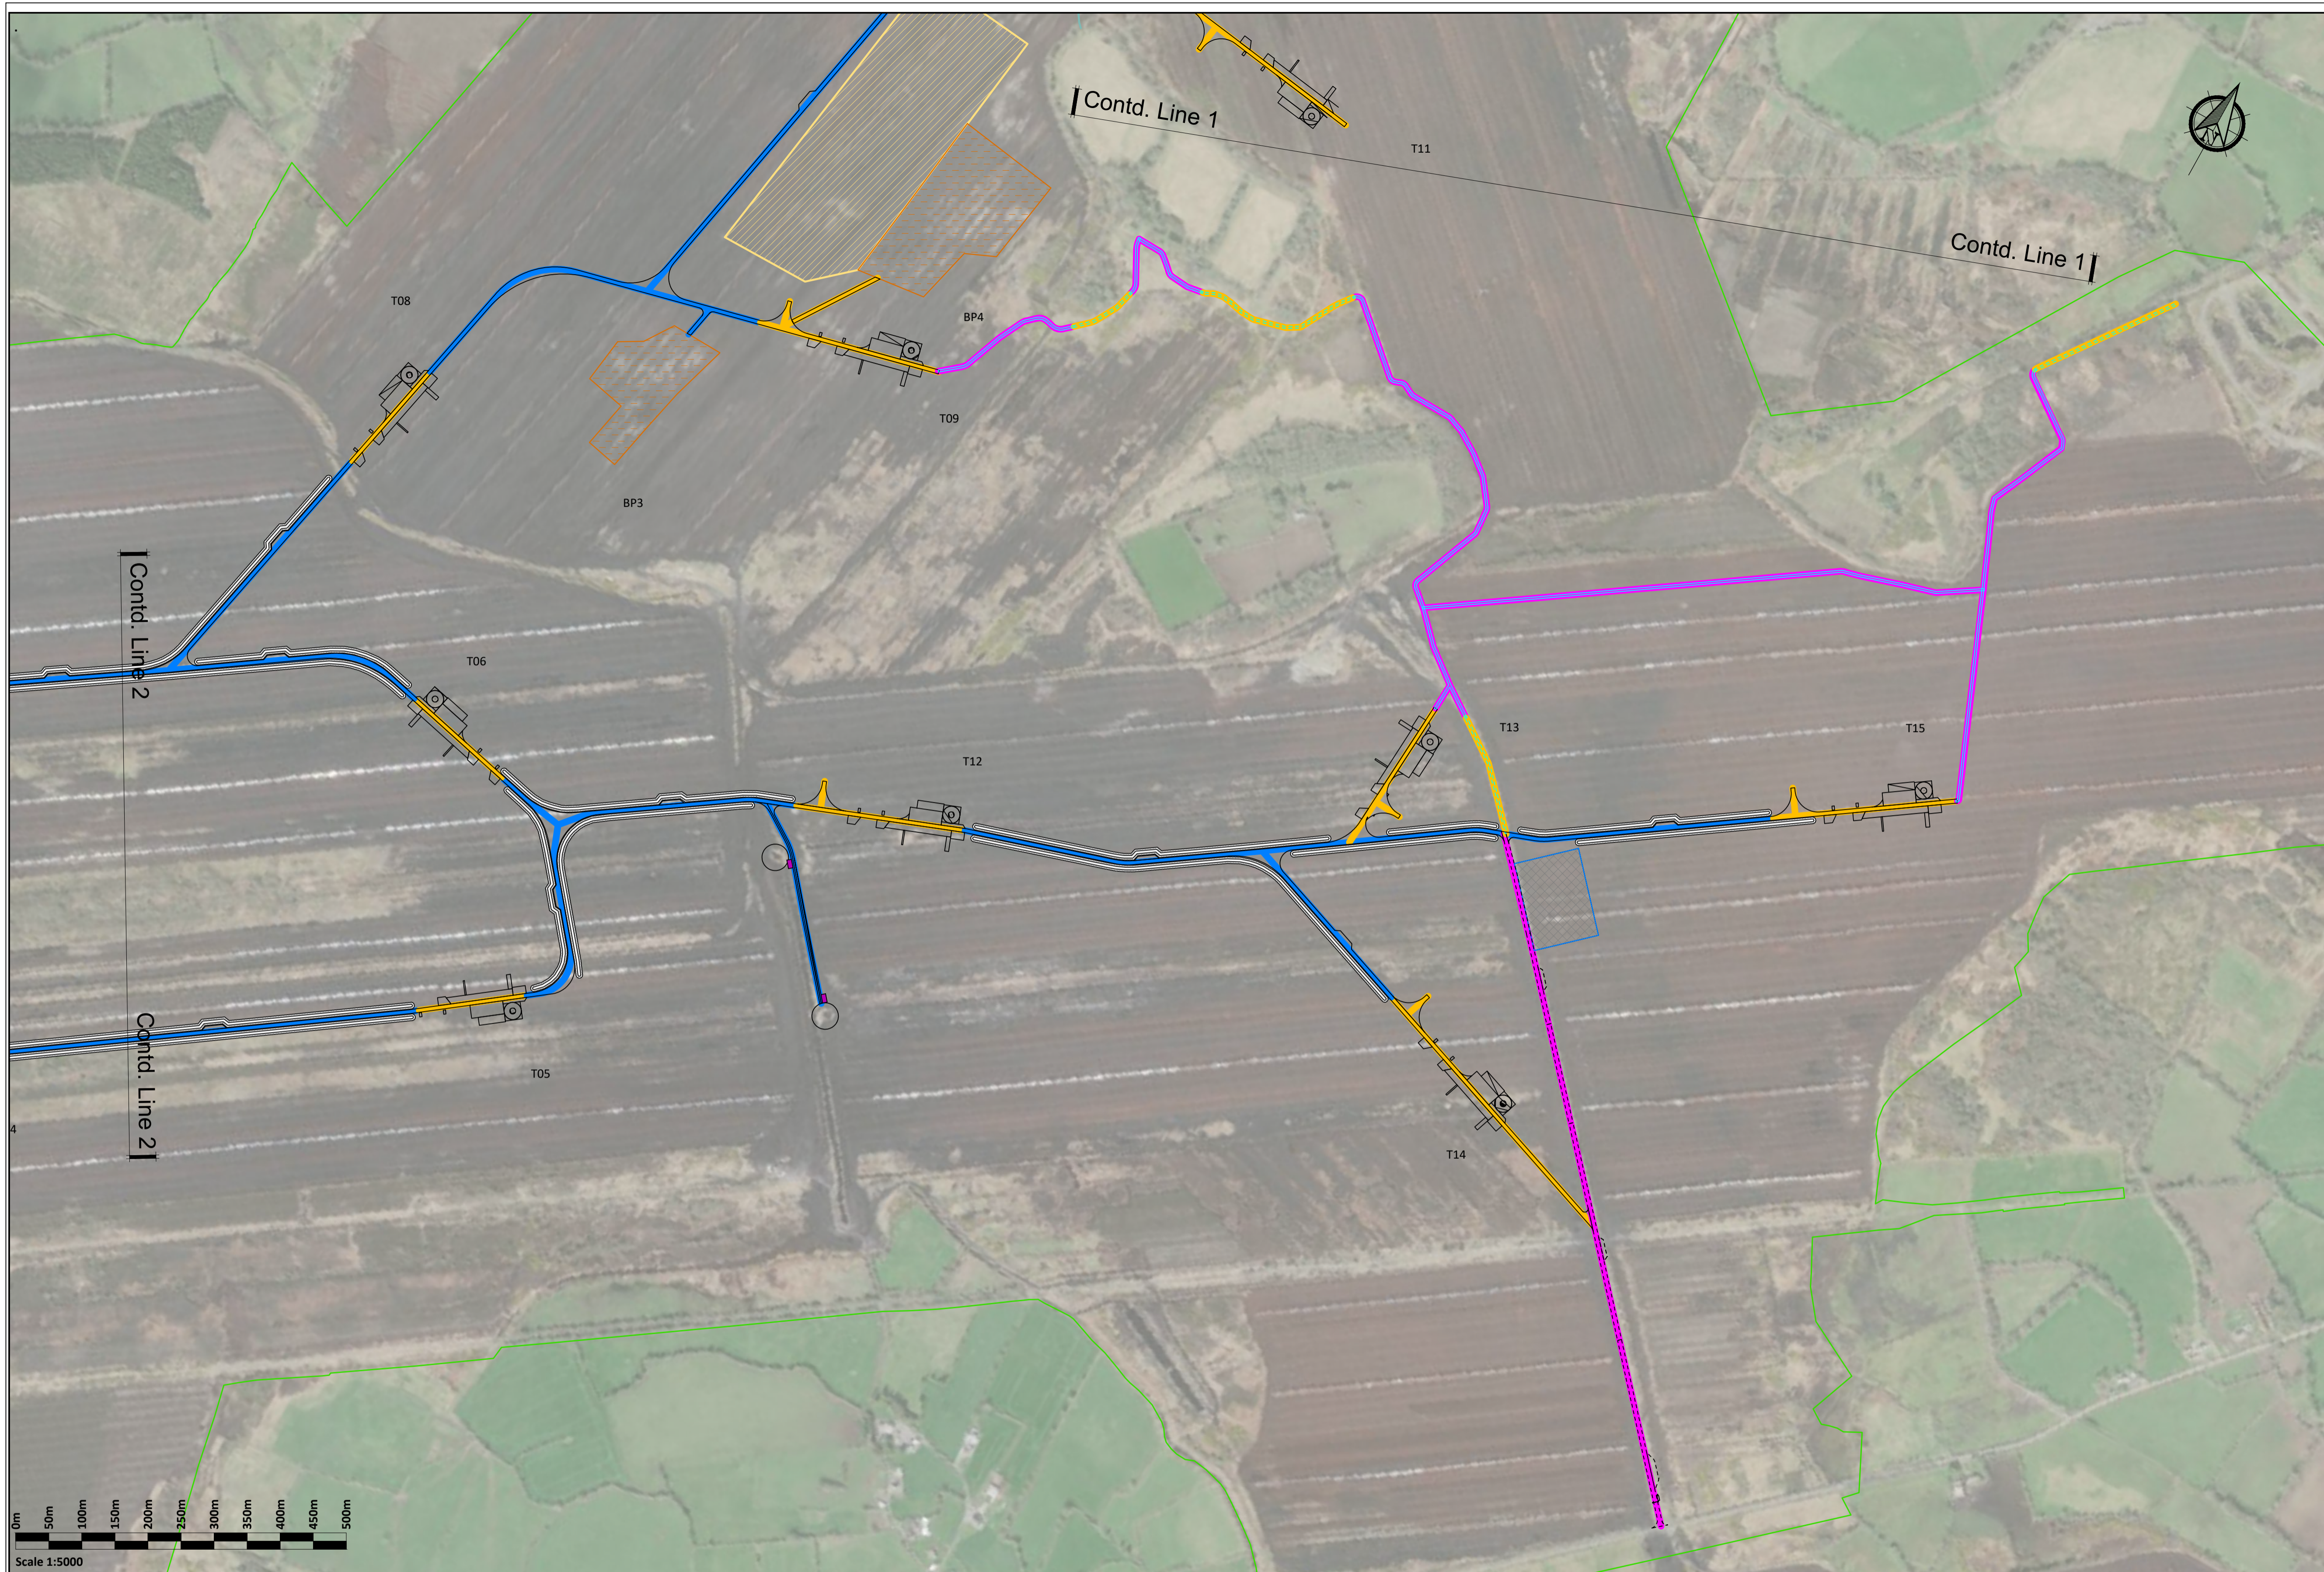
- Road Type Legend:**
- Type A - New Excavate & Replace Internal Track
  - Type B - New Floated Internal Track
  - Type C - Upgrade of Existing Excavated Internal Track
