**GEOTECHNICAL & PEAT  
STABILITY RISK  
ASSESSMENT REPORT**

# LEMANAGHAN WIND FARM, CO. OFFALY

## Geotechnical & Peat Stability Risk Assessment Report

# Geotechnical & Peat Stability Assessment Report Lemanaghan Wind Farm

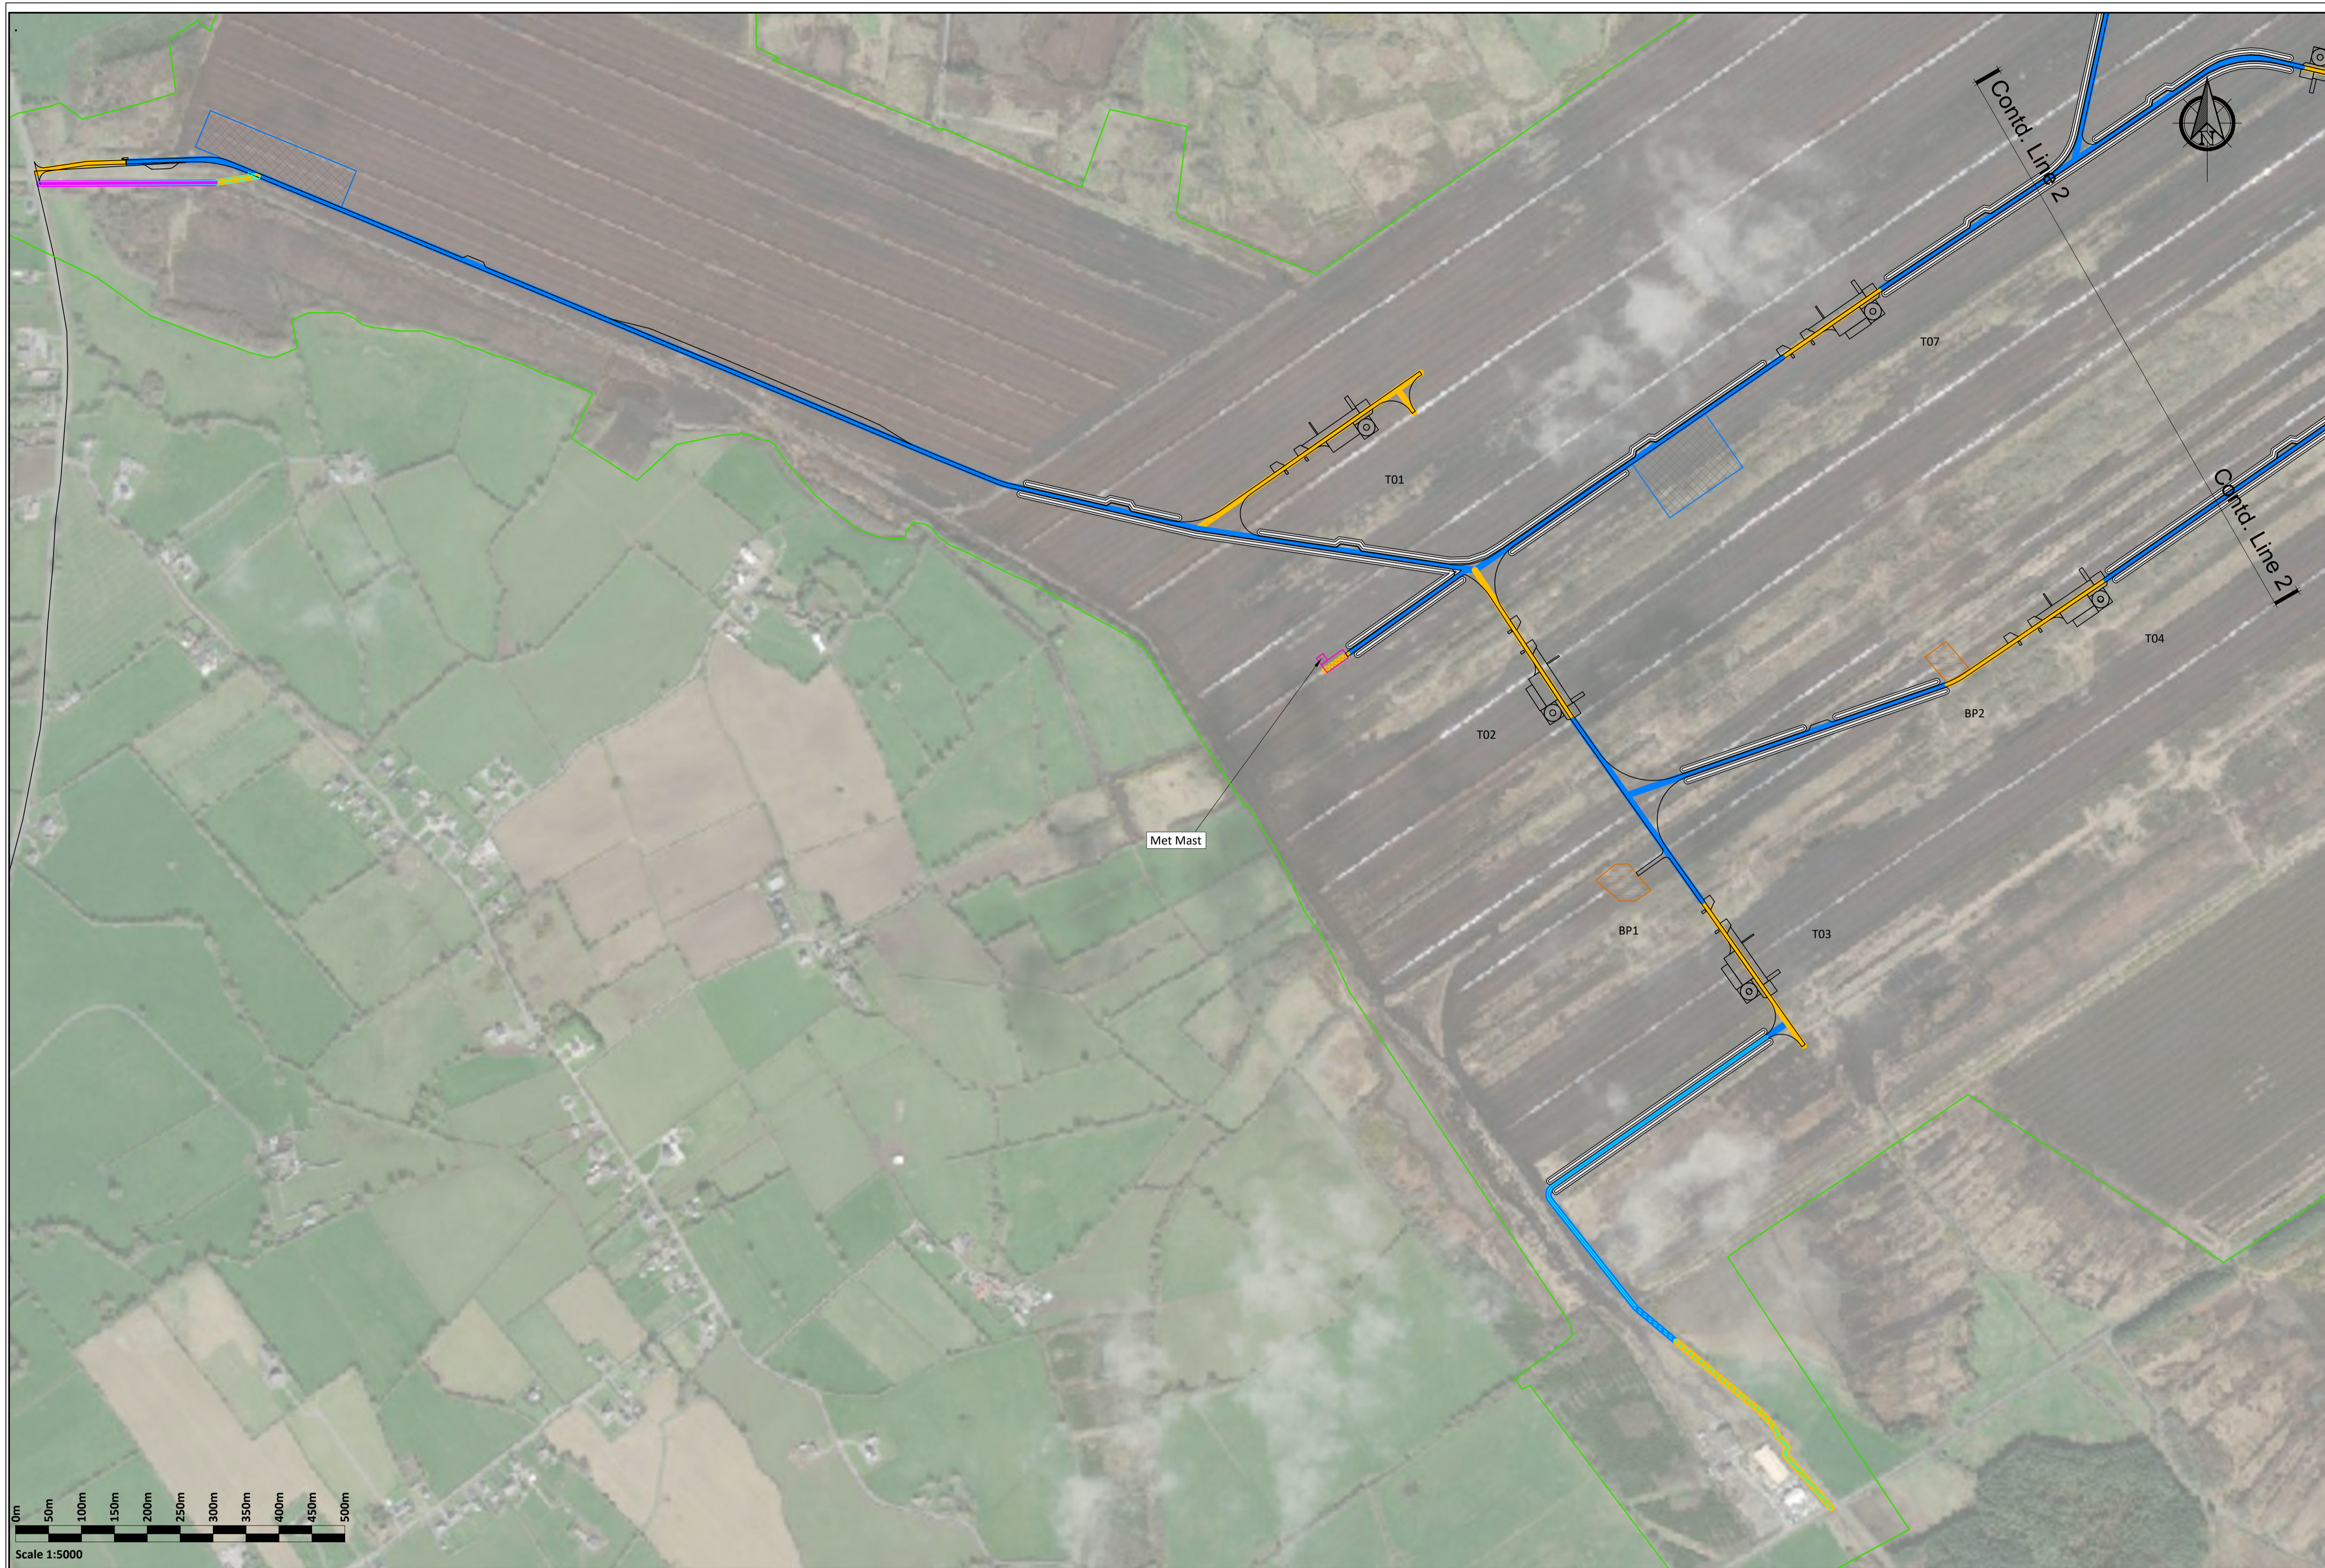
- Road Type Legend:**
- Type A - New Excavate & Replace Internal Track
  - Type B - New Floated Internal Track
  - Type C - Upgrade of Existing Excavated Internal Track

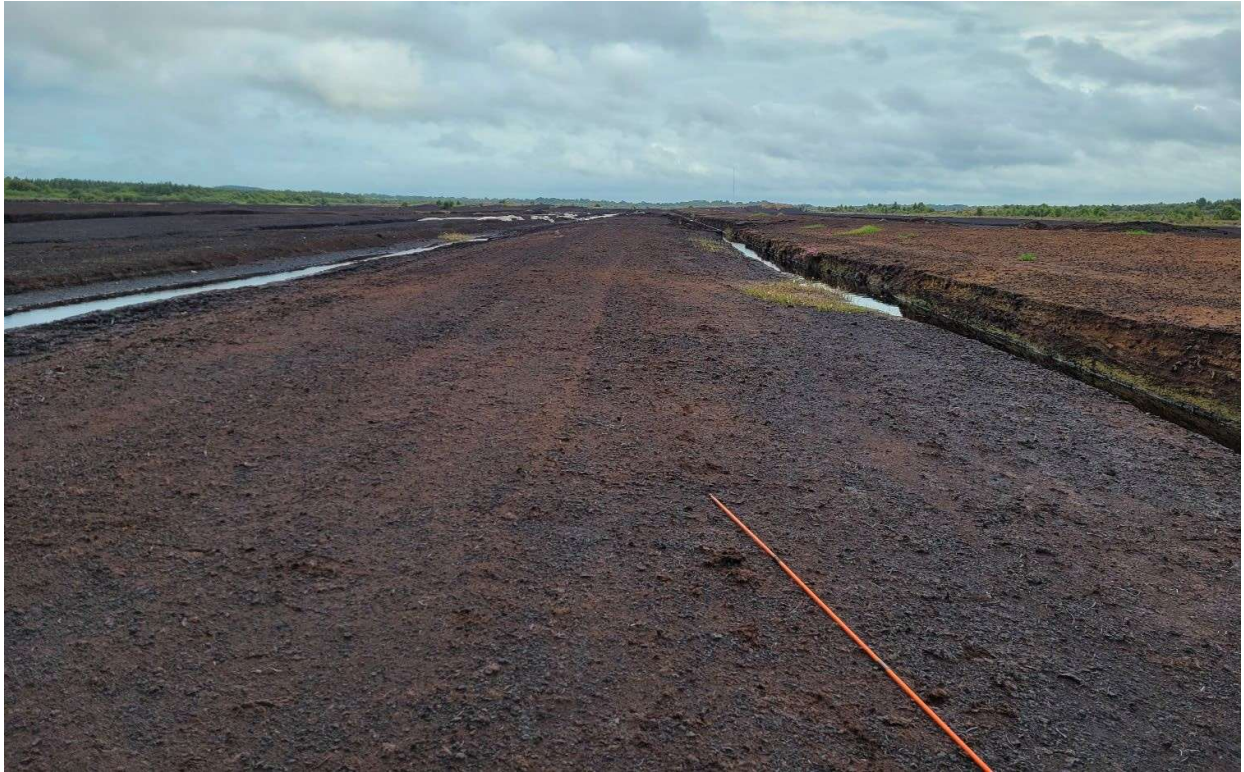
Figure A- 1    Open worked peat

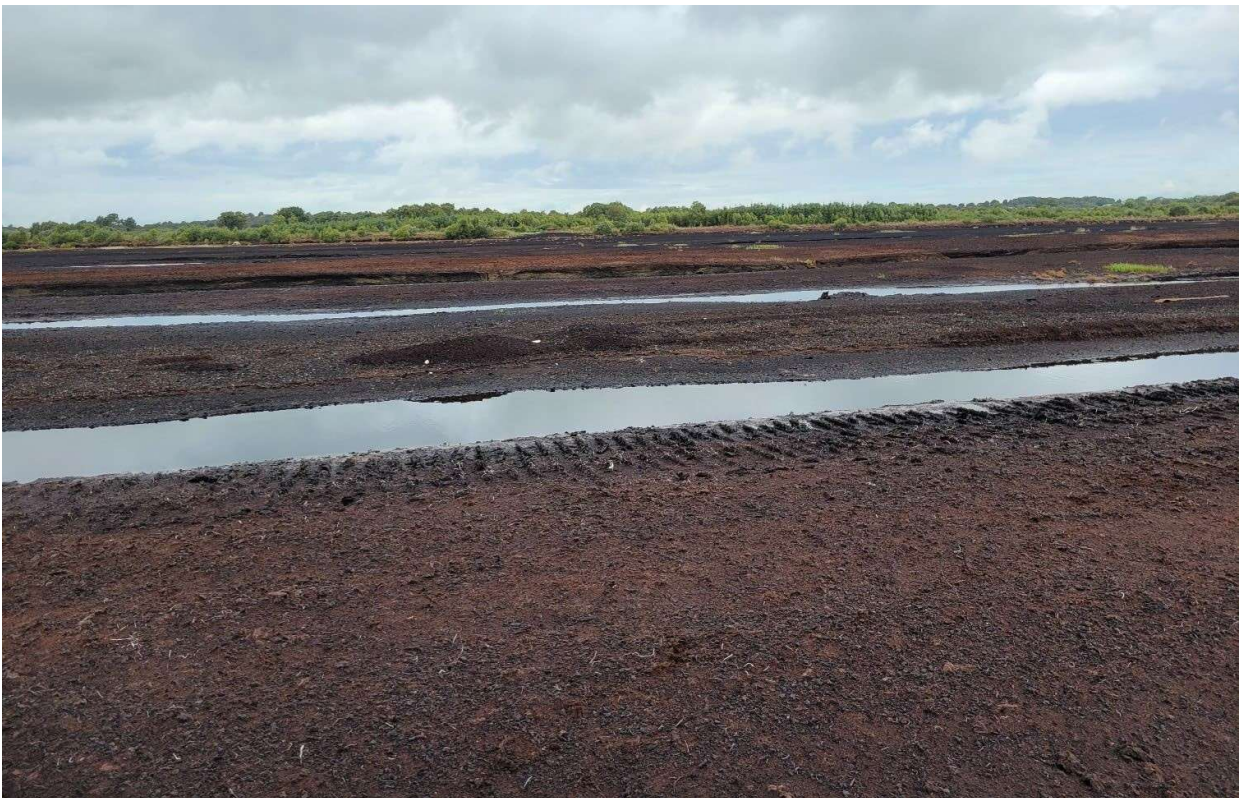
Figure A- 2    Open peatland with ponded water in drains

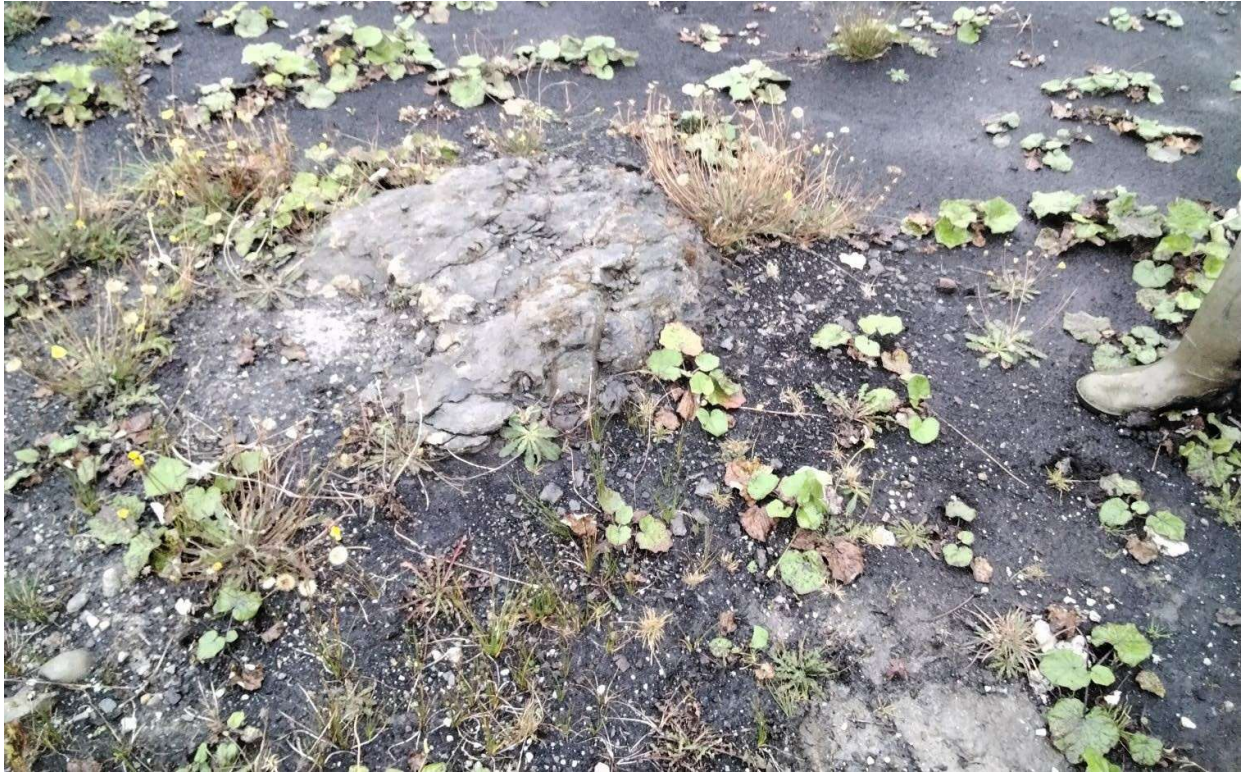
Figure A-3 Possible Rock outcrop at location of proposed borrow pit

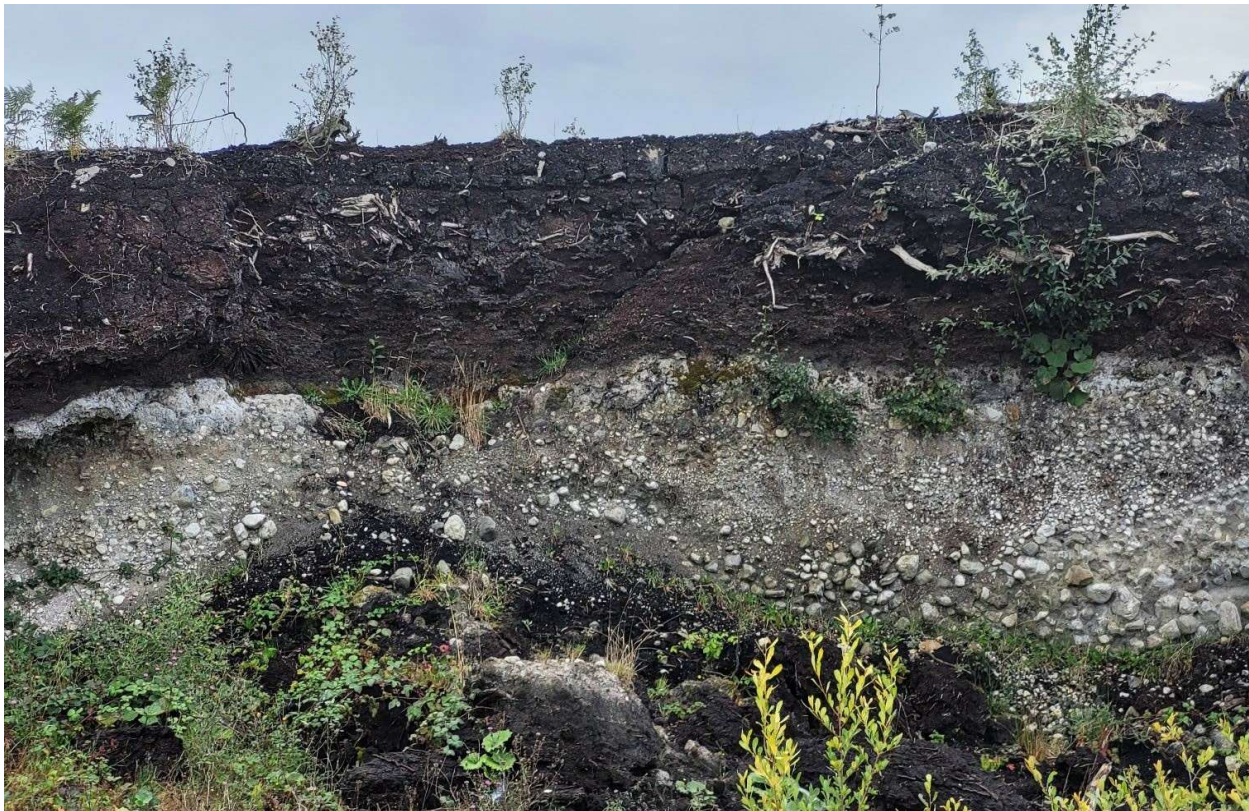
Figure A-4 Soil Profile of Peat overlying Glacial Till.
